## The Bank Job: the safe removal of a concrete bank safe

*Approached by a potential client to quote for the removal of a walk-in concrete safe in a recently vacated branch of HSBC Bank in Worthing, Hawes Diamond Drilling was challenged with the task of returning the site to its original footprint, prior to the bank's use. Bruce and Sarra Hawes of Hawes Diamond Drilling report.*

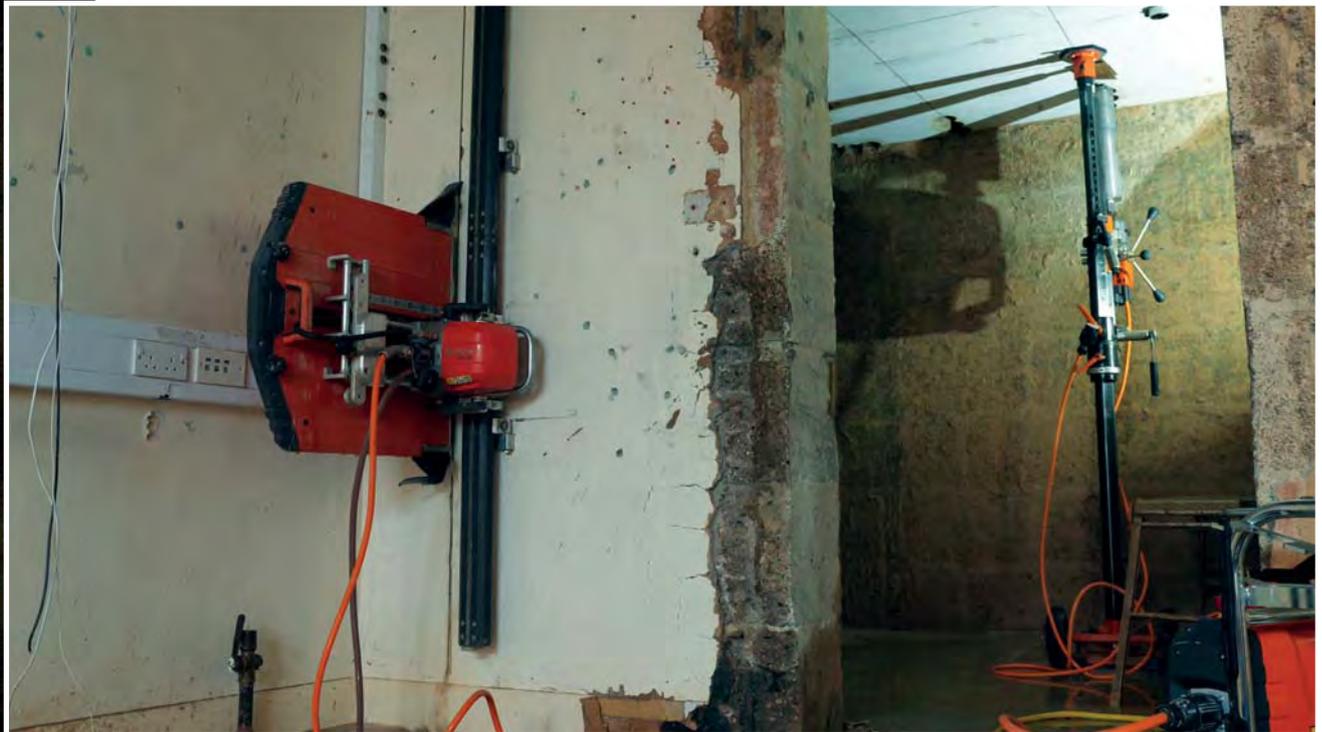
After the removal of the heavy safe door, work commenced utilising a Husqvarna DM650 drill motor fitted to a DS50 gyro rig. This enabled the team to carry out the required inverted drilling to the roof slab. Holes were drilled into the corners of the slab and the intersections with walls in the locations where it was intended to track saw the slab into sections. During this operation it was discovered that the safe was formed of precast planks/beams, which had been installed over three twisted 16mm rebars at close centres and subsequently grouted in. This made removal of the top slab even more difficult, in terms of support requirements, to guarantee that only the designated section was removed at a time to ensure there was no danger of an uncontrolled collapse.
